# **The Performance of Low-Rise Open Span Heavy Steel Structures In Extreme Winds**

**A REPORT**

**CIVIL ENGINEERING**

**June, 1997**

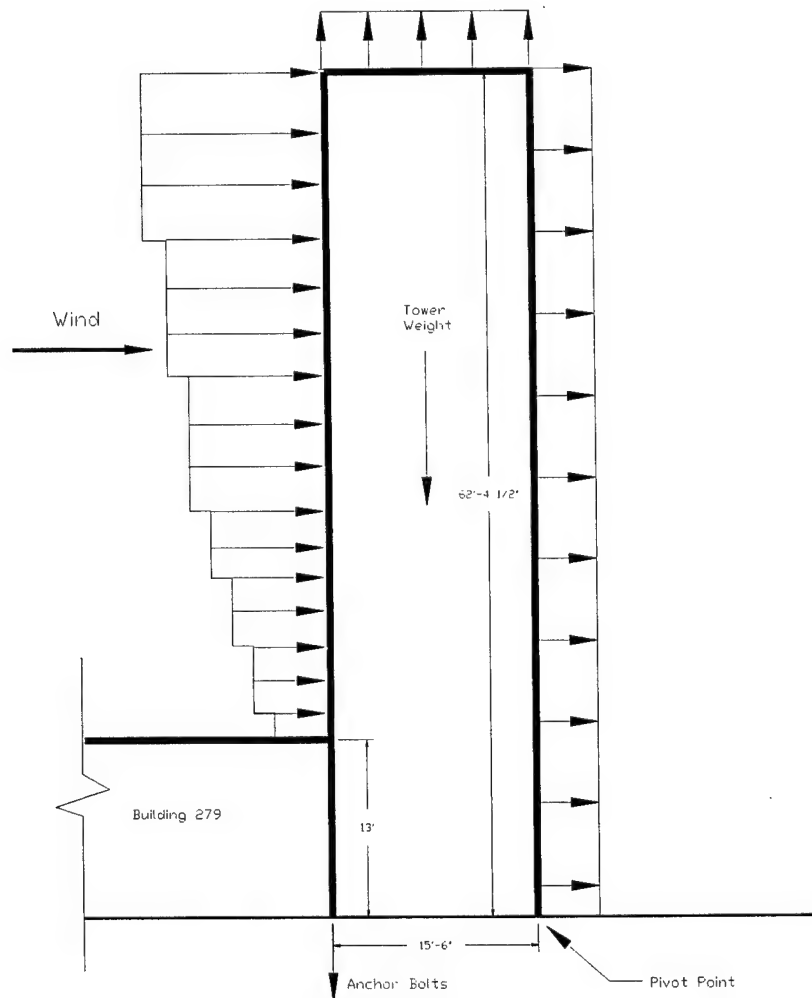
Figure 4.11 Forces Acting on Parachute Tower

The wind that caused the collapse of the parachute tower was generated by the Altus, Oklahoma tornado that was described earlier in Section 3.5. The wind caused the collapse of the parachute tower by generating enough force to cause failure of the column anchor bolts and also overcome the righting moment generated by the weight of the building. An illustration of the forces acting on the structure can be seen in Figure 4.11, below.

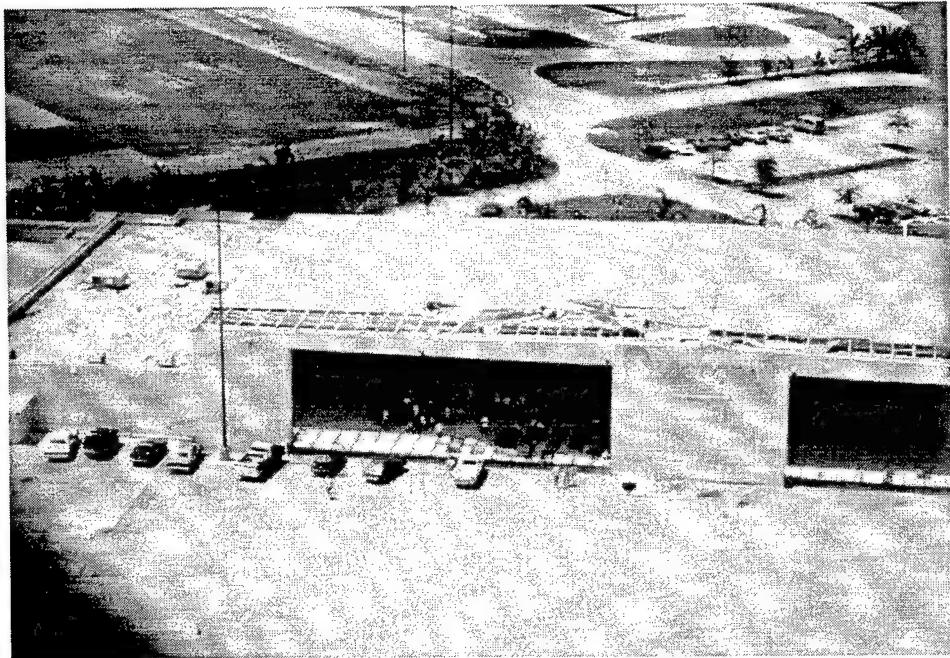
Figure 4.24 Elevation of Beechcraft Hangar

The main component that was damaged on all three hangars was the roof decking. The corrugated siding on the front of the Beechcraft hangar also received minor damage at the door pocket, see Figure 4.25.

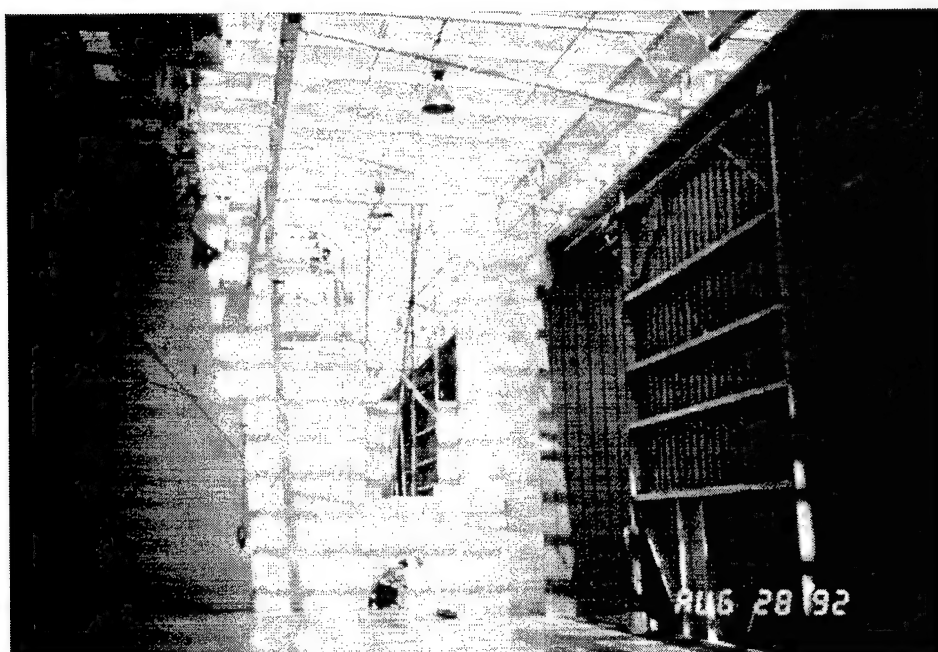
Figure 4.26 Interior Elevation of Beechcraft Hangar

The Beechcraft hangar shown in Figures 4.23, 4.24, and 4.25 is approximately 200 feet long, 60 feet wide, and 40 feet tall. The structure has a gable roof with a very slight pitch (approximately 1/4" per foot). The exterior walls are covered with corrugated metal siding and the roof is covered with corrugated metal decking. The main structural system is made up of wide flange steel columns, large custom girders, and z shape roof purlins. The lateral loads are transferred to the foundation via steel cross bracing running between the columns. All of the main structural elements can be seen in Figure 4.25. The other two hangars that are shown in Figure 4.26 are very similar in size and construction to the Beechcraft hangar.
